## **Erosion/deposition of doped graphite tile with SiC coating under a long term plasma operation in HT-7**

J.S Hu\*<sup>1</sup>, N. Ashikawa<sup>2</sup>, J.G Li<sup>1</sup>, X.D Zhang<sup>1</sup>, N. Noda<sup>2</sup> and HT-7 team

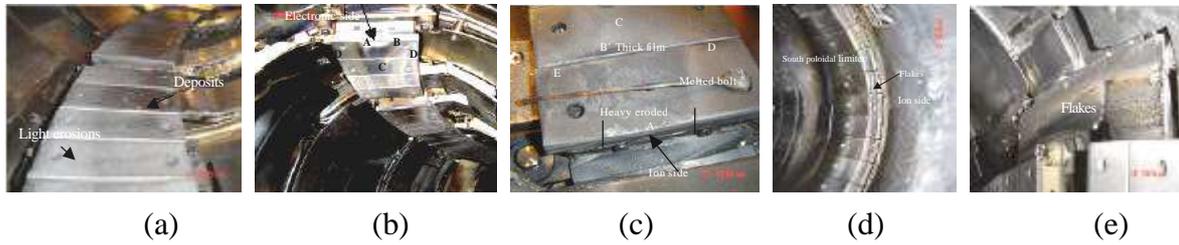
In order to achieve long plasma in HT-7(R=1.22m, r=27cm), the limiter system was upgraded in the end of 2003[1]. The GBST1308 (1%B, 2.5%Si, 7.5%Ti) doped graphite with 50~100µm SiC gradient coatings was used as limiter material [2][3]. In the 2004 campaign of HT-7, a total of 11079 plasma shots with more than 200 shots longer than 100s and several tens high performance discharges over one minute were operated. The longest plasma was reached 240s with a central electron density  $0.8E19m^{-3}$  and temperature over 1.0keV. The highest temperature detected at 3mm under plasma surface was below 400°C in long plasma discharges. Most tiles, 198 in 223 tiles, were observed with light erosions and thin deposition (see Fig.1(a)). Only two group tiles were destructed due to bolt melt and impacting of comparatively high parallel heat flux of plasma (see Fig.1(b,c)). Apparent flakes were observed at both sides of the poloidal limiters tiles and on the liners (see Fig.1(d,e)). Dust can be also observed on the limiters and liners.

A few similar characteristic areas were selected to analyze destructed surface morphology, which schematic locations were marked in Fig.1(b,c). The micro-picture at center of zone A appears to be one of mechanical separation of the graphite particles and an accumulation as a consequence of the extremely high thermal loading(see Fig.4(a)). The edge of zone A seems that the ablated graphite was directly dragged out by the ablation of considering large fragments at the center (see Fig.4(b)). The zone B with noticeable 'metal' shine has rich averagely distributed Ti. Thin film was formed (see Fig.4(c)) One sample film about 600 $\mu\text{m}$  at zone B' was grown (see Fig.4(d)). The film seems that part of sputtered graphite transferred and deposited in a short distance. Hard film up to 100 $\mu\text{m}$  was observed at the root of the film with apparent strides. About 500 $\mu\text{m}$  soft film was formed at the top. Beside 72.1% carbon, there is 21.17%Ti and 5% Si. At zone C, micro-photos shows there are light erosions as similar as shown in the Fig.2. At zone D, the SiC coating remained very well. Dusts are easily observed on the zone E.

Flakes, formed a typical arc about 40mm far from the LCFS of plasma at the side of the graphite tile of poloidal limiter, see Fig.12(a). The composition is 45% C, 16.7% Fe, 13.6% Si, 10.5% Cu, 5.3% Cr, 2.9% Mn, 1.9% Ni, 1.7% Ti 1.2% Mo and 0.7% Al in the collected flakes, which seems that it is a mixture. Flakes were also observed on the surface of liners where SOL is only about 30mm, shorter than normal distance 40mm. The composition is about 23.8% Mn, 22.8% Al, 17.5% Fe, 15.0% C, 7.7% Si, 7.0% Cr, 3.9% Cu, 1.3% Ca and 0.9% Ni in the collected flakes. It indicted that the metal element are dominant materials. Dust also concentrated on the liners near the strongly eroded tiles. The collected powders from the liners have 73% carbon, 7 %Fe, 9% silicon, 2.7% Cr, 2.5% Ni.

Fig.1 Typical surface of the graphite tiles of the toroidal limiter after a long plasma operation (a, typical light erosions/depositions; b, Destroyed leading tiles near ICRF antenna; c, Destroyed tiles due to bolt melted; d, Flakes on the poloidal limiter; e, Flakes on the liners.)

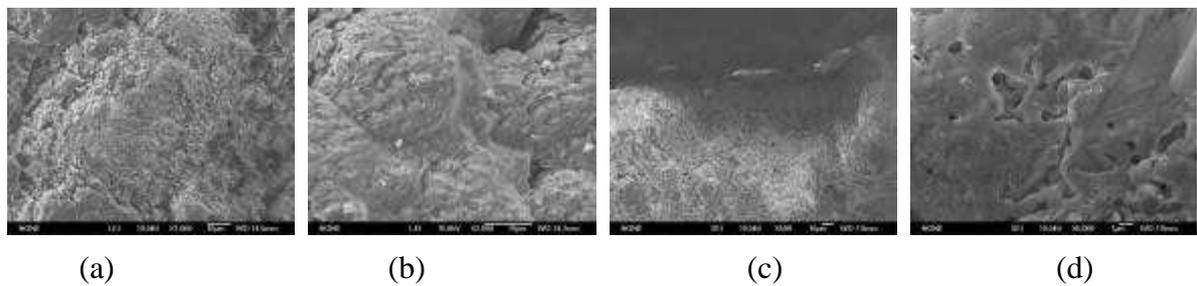
In most case, although the surface was preserved without macroscopic damage and SiC grains linked very well, the SiC coating became anomalistic due to light erosion. The head of 'outstanding' SiC grains were eroded out (see Fig.2(a)). Owing to the fast particles from plasma, SiC grains became honeycomb-liked with the small holes, which are the apparent

impacted marks of particles from plasma due to physical sputtering (see Fig.2(b)). Due to the un-smooth surface of the SiC coating, installation irregularity and the ripple of magnetic field, the deposits film near light erosions are formed from a few tens nm covered only on the top of the 'outstanding' SiC grains to a few tens  $\mu\text{m}$  filled up the concaves of SiC coating (see Fig.2(c)). A very thin flake was formed on thick deposition. The deposited carbon with very small grain was closely joined but with a many hollows with a few  $\mu\text{m}$  in the length (see Fig.2(d)). The ratios of C/Si changed from 0.11 to 1.85 at various places, which seemed different thickness of carbon film. The picture of C density shows the carbon was deposited on the surface or filled into the gap of SiC grains. The Fe, representing stainless steel material, has decreasing grads from the surface. The depth profile of the deposition in the first 1.6 $\mu\text{m}$  was analyzed with XPS after sputtering surface about 3nm is shown in the Fig.3. The percentage of B, Si, Ti, Fe decreased from surface whereas that of carbon increasing till top percentage of carbon reached. Then due to SiC coating, the percentage of Si increased whereas that of C decreased.

Fig.2 Typical light erosions (a,b) and typical depositions in the concaves of the SiC coating surface of tiles (c. Section; d. Inner structure)

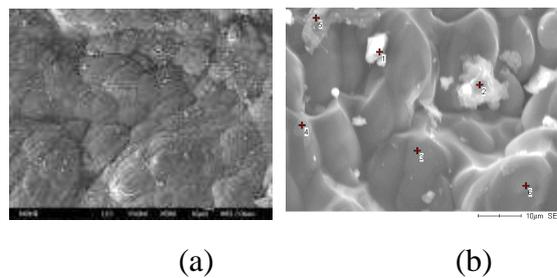
Dotted dust on the thin film show the depositing process before forming film (see Fig.5(a)). In most case, dust dimension is different, from very small to a few  $\mu\text{m}$  (see

Fig.5(b)). The density pictures showed that powder 1 is a typical Al dust and the powder 2 is a typical carbon dust. The dusts are a mixture with different material. For example, dust 1 has 29.5%B, 15.7%C, 22.6%Si, 19.3%Al, 1.1%Ti, 1.8%Fe.

Fig.3 Typical depth profile of deposition Fig.5 Dust in the gap among SiC grain

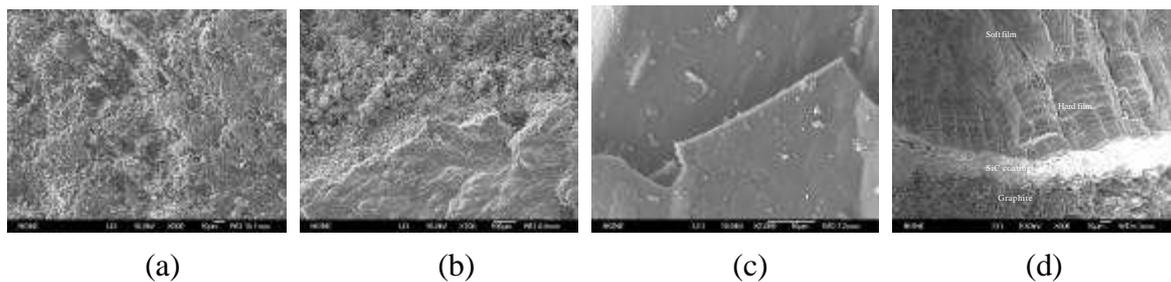
Fig.4 Typical surface of destroyed tile (a, destroyed zone; b, transition area; c, metal shine zone; d, Thick film.)
