The properties of contaminated films deposited on in-vessel mirrors in Large Helical Device, Tore Supra, TCV and TRIAM-1M

V.S. Voitsenya¹, A. Sagara², M. Lipa³, G. De Temmerman⁴, H. Zushi⁵, A.I. Belayeva⁶, V.N. Bondarenko¹, Konovalov¹, N.I. Naidenkova¹, R.A. Pitts⁷, I.V. Ryzhkov¹, B. Schunke³, A.N. Shapoval¹, K.A. Slatin⁶, Ch. Gil³, V.G. A.F. Stan¹.

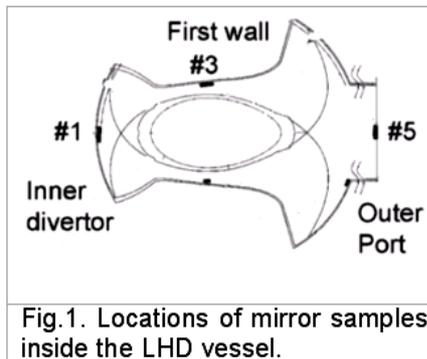
Fig.1. Locations of mirror samples inside the LHD vessel.

Three SS mirrors were mechanically polished, rinsed in an ultrasonic bath with acetone, and exposed in LHD for the whole 3rd campaign (for details of operating regimes see [5]) without protection from glow conditioning discharges. Sample #1 was positioned near the divertor region, #3 – close to the plasma border, and #5 – deeply in the diagnostic port (Fig. 1).

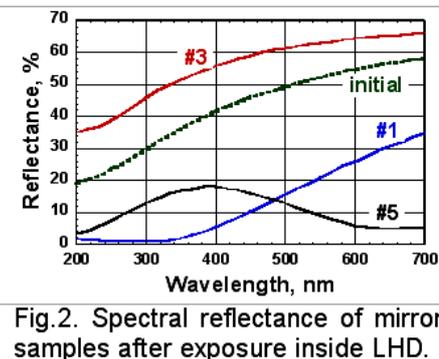
Fig.2. Spectral reflectance of mirror samples after exposure inside LHD.

After the samples were removed from LHD, their reflectance was again measured, and the surface of samples was analyzed by several methods [2]. From the initial identical level, reflectance, R , of mirrors #1 and #5 dropped strongly Fig. 2, whereas the reflectance of #3 increased significantly [2]. The reductions of R of samples #1 and #5 were due to absorption

of light by the contaminating films, composed from ~40% Fe and ~40% C for #1 and ~90% C

for #5 (the rest – O and H). The thickness of films was, correspondingly, ~30 nm and ~50 nm with optical indices $n_1 \approx 2.5$, $k_1 \approx 0.33$ and $n_5 \approx 2.45$,

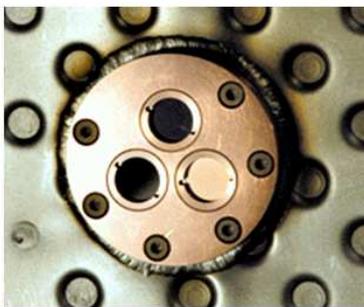
Fig.3. One of holders with mirror samples fixed to the inner wall of Tore Supra vacuum vessel.

Six mirrors from Mo, SS, and Cu have been installed in two CuCrZr holders on the inner wall of torus with centres located at poloidal angles of 7.6° and 15.4° above the central plane (Fig. 3) and positioned ~14 cm from the LCFS (last closed flux surface).

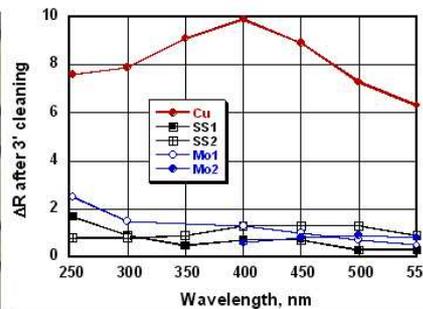
Fig.4. Increase of reflectance of mirror samples exposed inside Tore Supra after 3 minute cleaning with low energy H^+ plasma ions.

All samples were cleaned by hydrogen plasma of ECR discharge [6]. The first exposure lasted 3 min with grounded mirror holder, when due to sheath potential an ion energy did not exceed 15 eV. The effect of this exposure shown in Fig. 4 does evidently indicate that Cu mirror was contaminated with a film which was easily taken off from its surface just due to chemical erosion. In contrast, such low energy of H^+ ions has no effect on cleaning the Mo and SS mirrors. The reflectance of Mo and SS mirrors became to rise only after the energy of ions was increased to 100 and 200 eV, and the total cleaning procedure took much longer time, in spite all mirrors were exposed in TS in close each to other. This fact gives grounding to make an important conclusion that the properties of film depend on the material of substrate.
