## Effect of radiation damage on material erosion in plasma

B.I. Khripunov, O.K.Chugunov, V.M. Gureev, V.S. Koidan, S .N. Kornienko, B.V.Kuteev, S.T. Latushkin, A.M. Muksunov, V.B. Petrov, A.I. Ryazanov, V.P. Smirnov, V.N. Unezhev

*Russian Research Centre "Kurchatov Institute" (RRC KI), Moscow, Russia*

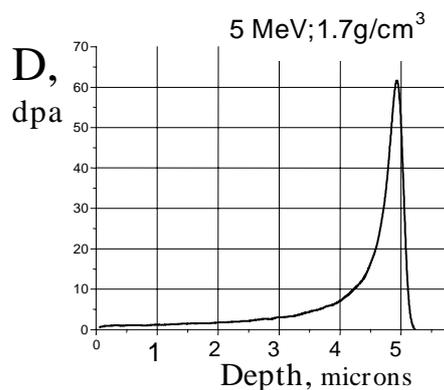
Fig. 1.

The radiation damage depth distribution after ion irradiation is highly non-uniform having a maximum near the projective penetration depth of  $^{12}\text{C}^+$  ions. Fig. 1 shows the result of numerical calculation for profile of the primary radiation defects  $D$  (dpa) as a function of depth for a carbon material with density  $\rho=1.7 \text{ g/cm}^3$  after irradiation with 5 MeV carbon ions to the dose  $10^{18} \text{ ion/cm}^2$ . Maximal value in this distribution  $D_{\text{max}}=65 \text{ dpa}$  lies at a depth of  $\sim 5 \mu\text{m}$  while the average value is  $\langle D \rangle=9,7 \text{ dpa}$ .

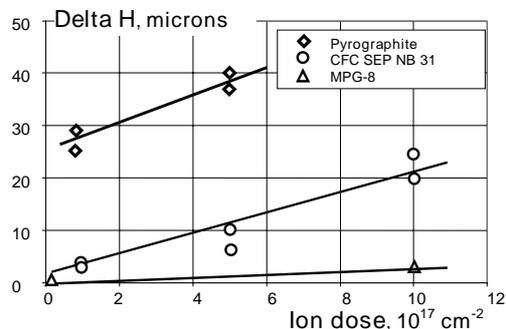
Fig.2.

Materials experience radiation-induced erosion and deformation under fast ion impact. The measured values of linear deformation  $\Delta H$  (swelling) are given in Fig.2 for the materials under study as a function of the ion irradiation dose. Maximal deformation corresponded to

pyrographite. The CFC showed also an important deformation under irradiation. Surface microstructure modifications were observed after ion irradiation, the most pronounced changes corresponded to pyrographite and CFC. Splitting, cracking and surface deformation after fast ion irradiation are shown in Fig. 3 (a- pyrographite 10 dpa; b- MPG-8, 5 dpa; c – CFC, 10 dpa, right on the photo is the non-irradiated area).

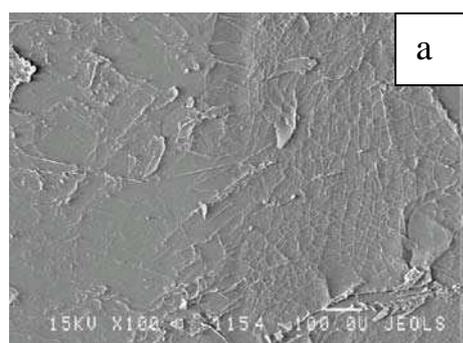
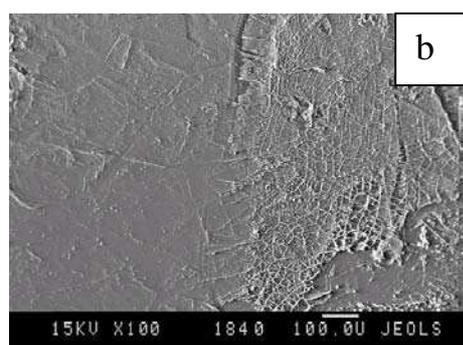
Fig. 4.

Surface modification after plasma bombardment is illustrated in Fig. 4 (pyrographite 1 dpa; a – before plasma; b – after plasma). Erosion of the damaged area (right on the photo) is well seen.

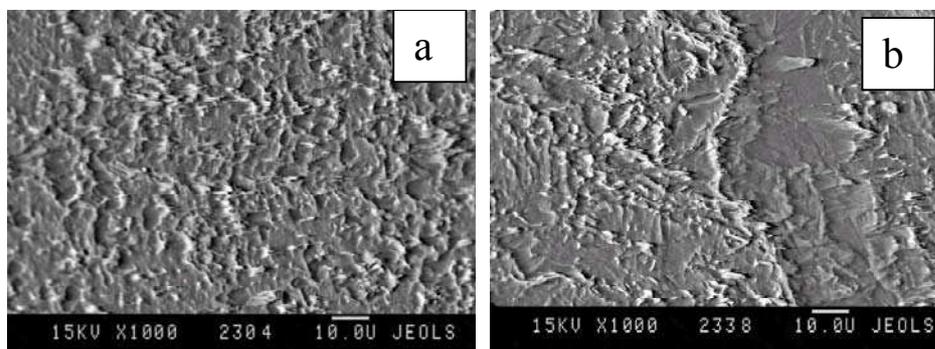
Fig 5.

Fig. 5 shows: a – MPG-8, 5 dpa; b – SEP, 10 dpa after plasma exposure. Formation of the holes and pyramids is characteristic for the erosion process. Erosion along the crack is seen on the SEP photo. Average erosion rate  $G$  was deduced from the weight losses for all plasma runs for each material. It was found to rise when the erosion reached the layer with the maximal radiation damage level. All three materials showed tendency to enhancement of  $G$  in
