Fast visible camera installation and operation in JET

This article is a summary of the measurements of the recently installed wide-view fast visible camera in the Joint European Tokamak JET. Here we limit ourselves to a description of the different phenomena and leave for forthcoming articles a more extensive analysis of every phenomenon.

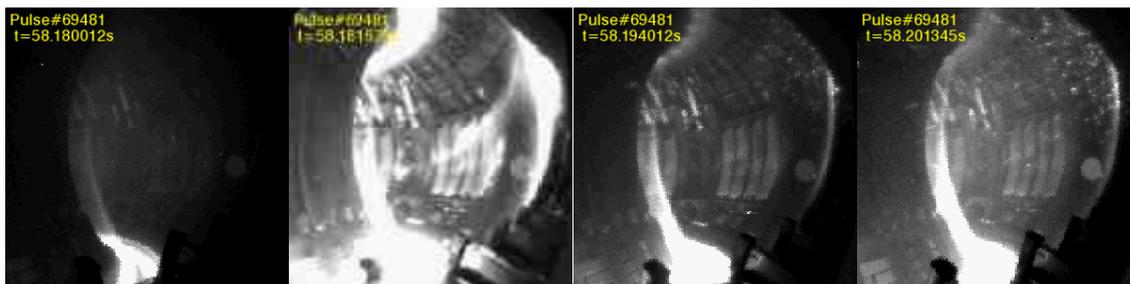
Figure 1. Particle expulsion from a poloidal limiter. Images are taken at 3 kfps with 166 μ s exposure time.

2.1 ELM physics and plasma-wall interaction - The fast camera has proven to provide useful information to study different fusion plasma relevant issues including plasma wall interaction, ELMs and disruption physics. Figure 1 shows the expulsion of macroscopic particles from the wall after the occurrence of an ELM.

Some 6 ms after the sudden radiation increase caused by an ELM, a shower of solid fragments is seen to come out of an outer wall poloidal limiter and seem to be accelerated in the toroidal co-current direction (that is also the direction of the parallel plasma flows for this configuration). These particles can be seen for 50 ms.

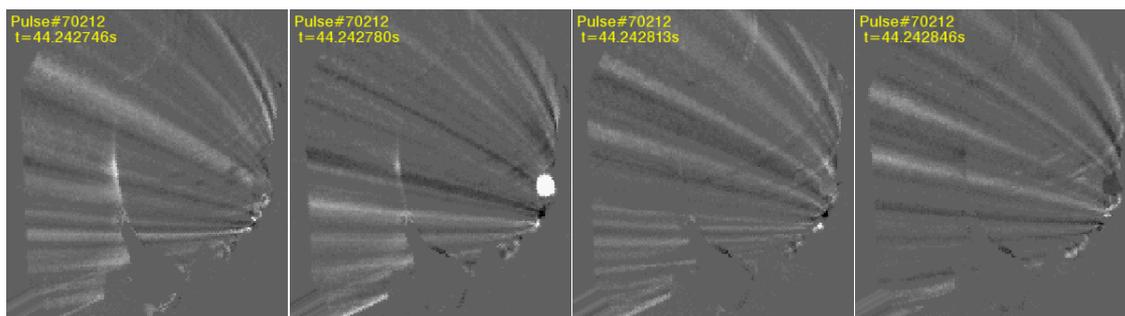
Figure 2. Filament development during an ELM (30 kfps, 25 μ s exp. time). The background images (calculated as the pixel median over 500 μ s) has been subtracted from the original frames to highlight the filamentary structure.

ELMs are commonly seen in the images as a sudden increase of radiation. For high power type-I ELMs like the one in figure 2, an associated filamentary structure can be observed as in other machines [2], [3]. In the high frequency recording of an ELM in figure 4, a helical interaction pattern can be seen on the wall within 40 μ s following the onset of the ELM (the associated D_{α} rise). This kind of interaction pattern has also been seen with infrared cameras in JET [4]. It should be noted that an ELM impact can produce localized particle desorption from the wall elements. These particles are transported parallel to the magnetic field and can also be seen as filamentary structures (figure 4, third and fourth frames) which are thus different from the ELM own structure.

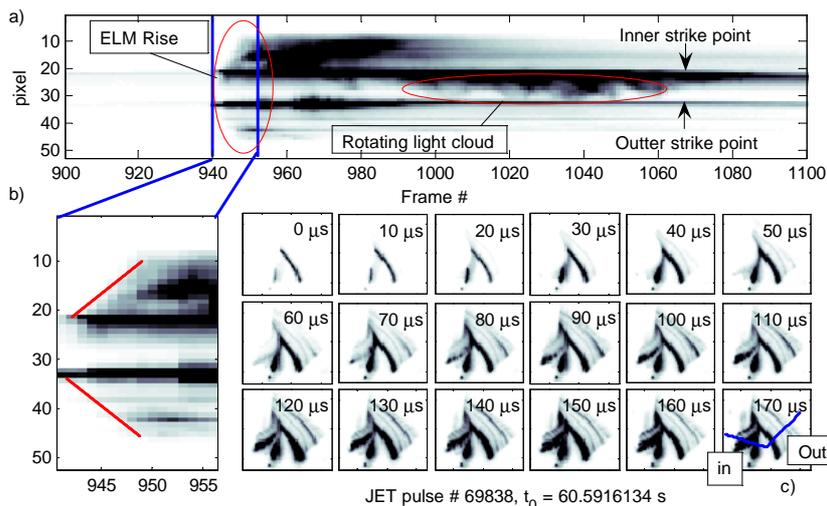
Figure 3. (a) Time trace of the pixels on the blue line in the last frame of (c) -approx. in a poloidal section. The radiation onset shows a delayed arrival to the ELM energy flux to the different divertor positions. (b) Close-up of the ELM rise. (c) Sequence of the divertor at the ELM onset (@ 100 kfps 9 μ s exposure).

2.2 ELM radial / parallel dynamics - Very fast framing can be achieved if the active part of the detector is reduced. Images in figure 3, show a 100 kfps frame sequence of the divertor during an ELM. The radiation increase starts very close to the

strike points (figure 3). The D_{α} rise progressively reaches further divertor positions up to the limiters shadows. Two possible causes of this delayed arrival have been identified as the radial decay of the parallel flow because of the SOL temperature profiles [4] and the intrinsic ELM radial velocity. The relative importance of these two factors is under investigation.

From figure 3 it is apparent that the volume light emission from inner divertor is stronger than that of the outer, consistently with the measured higher neutral density. An intensively radiating cloud localized in between the strike points is seen after the impact of some ELMs and appears to rotate in the toroidal direction (figure 3.a).

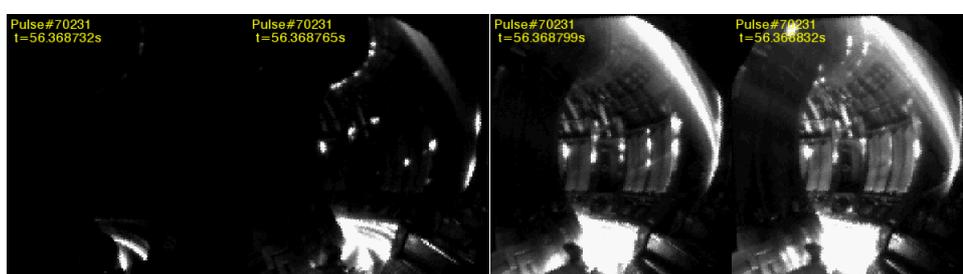
Figure 4. ELM onset and interaction with the wall (@ 30 kfps 25 us exposure). A helical wall-interaction pattern can be seen less than 40 us after the start of the D_{α} rise.

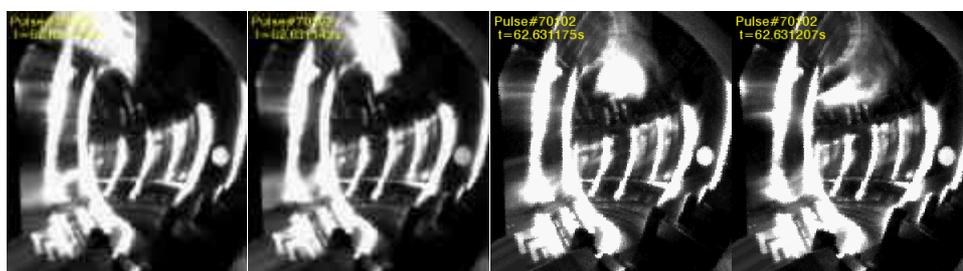
Figure 5. JET interior during a plasma disruption (@ 30 kfps, 25us exp. time). The magnetic configuration is largely lost and the plasma interacts strongly with the inner and outer walls. A light cloud is seen to move toroidally in the counter-current direction. It moves ~ 90 deg in the toroidal direction in the lapse of 3 frames. For $R=3m$ this gives $\sim 4 \times 10^4$ m/s

2.3 Plasma Disruptions - During disruptions (figure 5) the plasma detaches from the divertor as the current is lost and high particle fluxes are directed to the wall. MHD activity can also be seen as filamentation. In the course of a disruption a highly radiating MARFE-like ring could be seen which travels from the upper plate, where it formed, to the equatorial plane in the HFS in ~ 5 ms, where it keeps radiating for ~ 32 ms. After this time the plasma terminates violently.
